J.A.I.M.S

Cutting Tool Quality Inspection

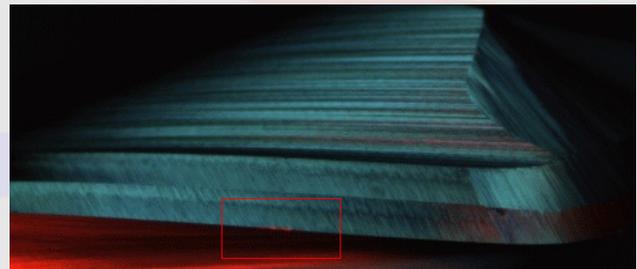
Color image 2 and subimage 3 visualizes the damaged cutting edge. Total image size is about 4mm in horizontal direction and 3 mm vertically.

Image 2: RGB image cutting edge. The damage is visible in the red rectangle. See also subimage (Image 3).

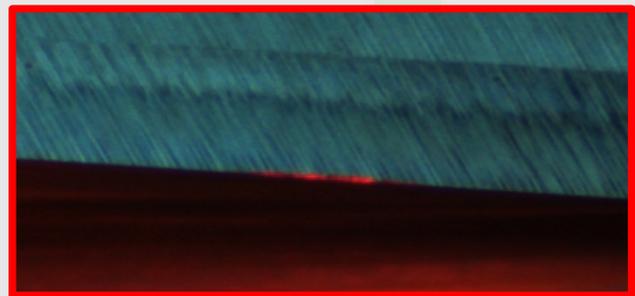
Image 3: RGB Subimage, red is the damaged edge.

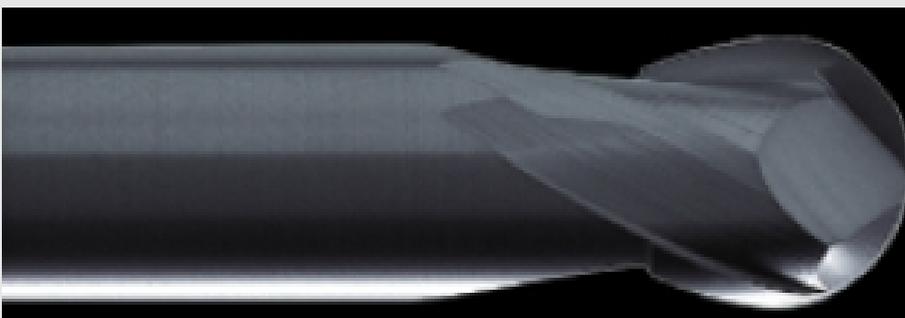
The tested cutters are visual inspected but didn't match the quality level and are rejected.

Image 1: Investigated cutter: ball nose cutter type.

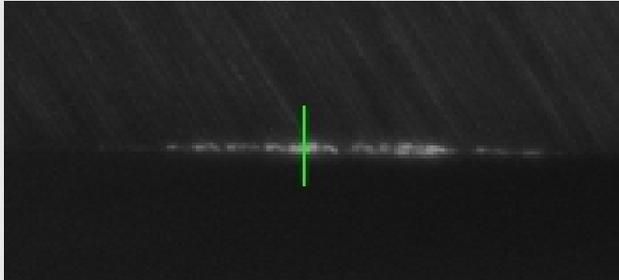
Image 4: monochrome subimage of the damaged edge.

The width of the damage in image 4 is 11 μm and the length 295 μm .

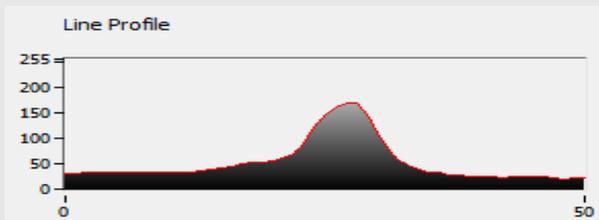
Due of very high contrast (graph 5) a reliable

Graph 5: intensity profile in vertical direction of the defect.

detection of the damaged edge is possible. After a detection the geometrical dimensions of the damage is measured.

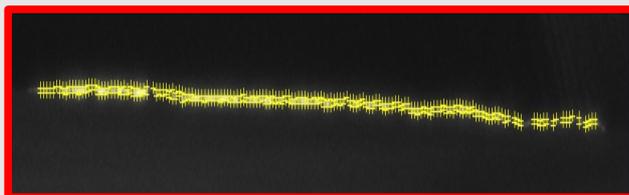
Image 7: subimage red rectangle of image 6 Length and width result of the damage. Yellow crosses are the detected damage points.

Image 7 shows the detected edges and the graphical representation (graph 8) shows the measured width of the damaged edge in pixels.

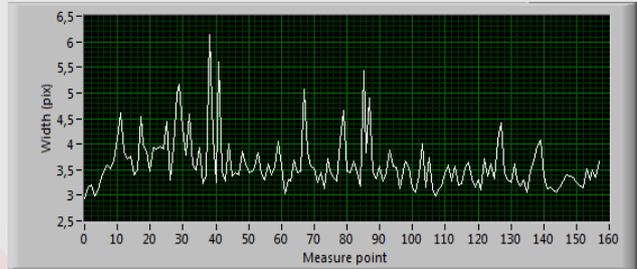
Graph 8: Measured width of the damage in pixels.

Scaling: =1.4 μm /pixel vertical and 7 μm /pixel horizontal.

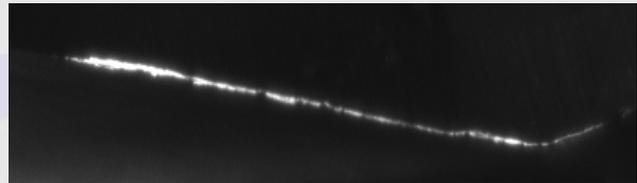
Even when the damage exceeds the 'linear' part of the ball nose cutter a reliable detection followed by an accurate measurement is performed. The width of this damage is 6.6 μm over a length of ~1680 μm .

Image 9: Subimage cutter. Damage length about 1200 pixels (~1680 μm).

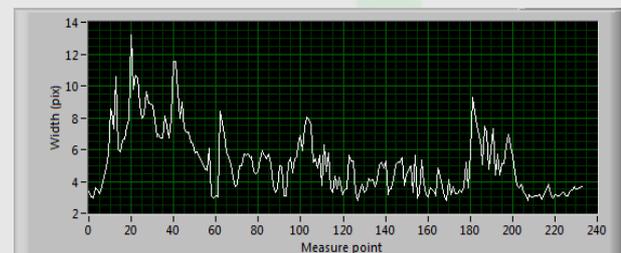
Graph 11: width of the damage in pixels. Measured between the corresponding edges of the damage (yellow crosses).
